14.15 – 14.45 Possibilities to use recycled aggregates in road construction works, examples from Estonia

# POSSIBILITIES TO USE RECYCLED AGGREGATES IN ROAD CONSTRUCTION – ESTONIAN CASE STUDY

# Maardu-Raasiku road (No11103) Test section km 3,4-3,9

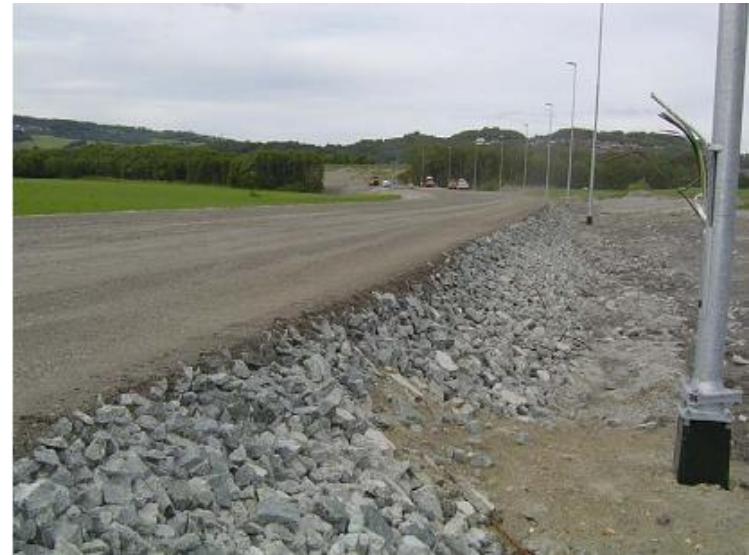
In Norway, built in 2003

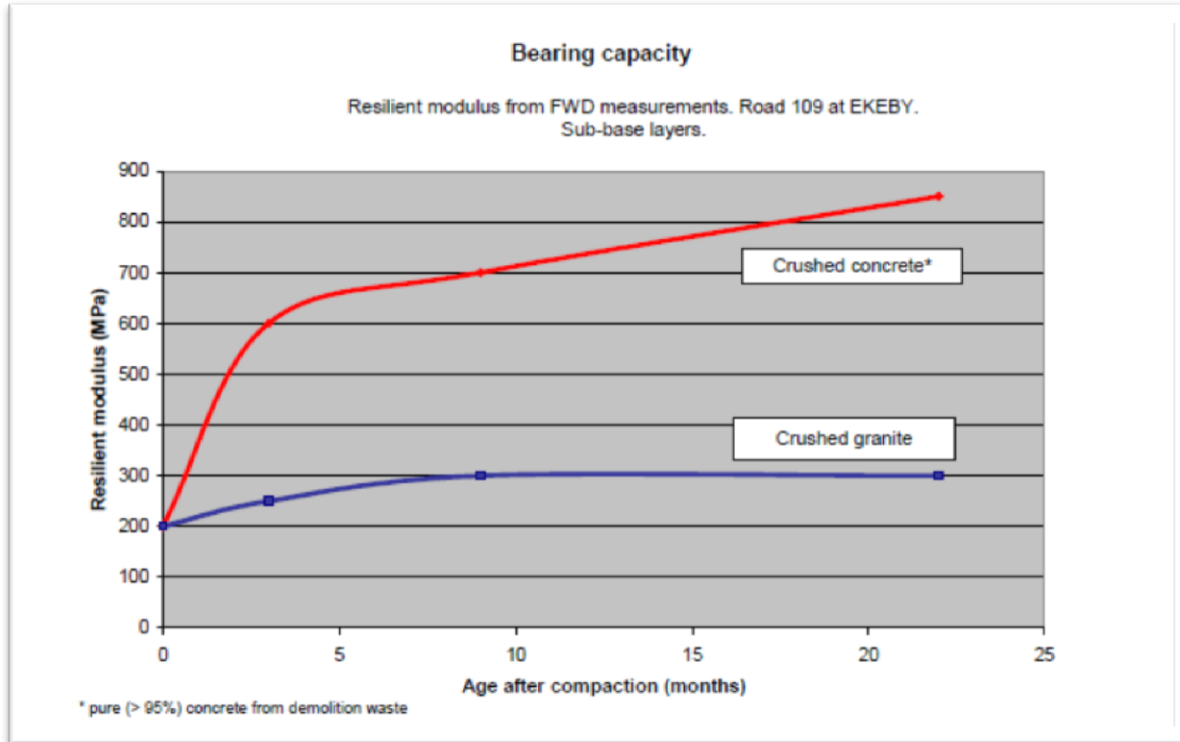
## High bearing capacity of crushed concrete layer

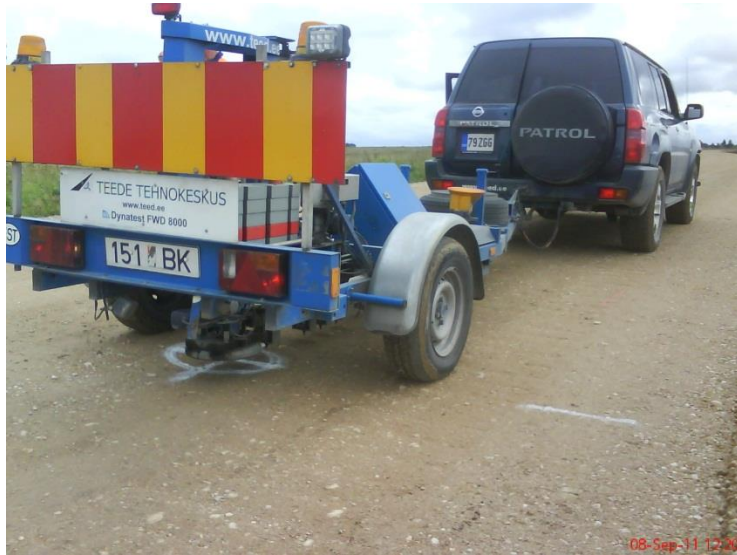
## FWD on gravel sub-base

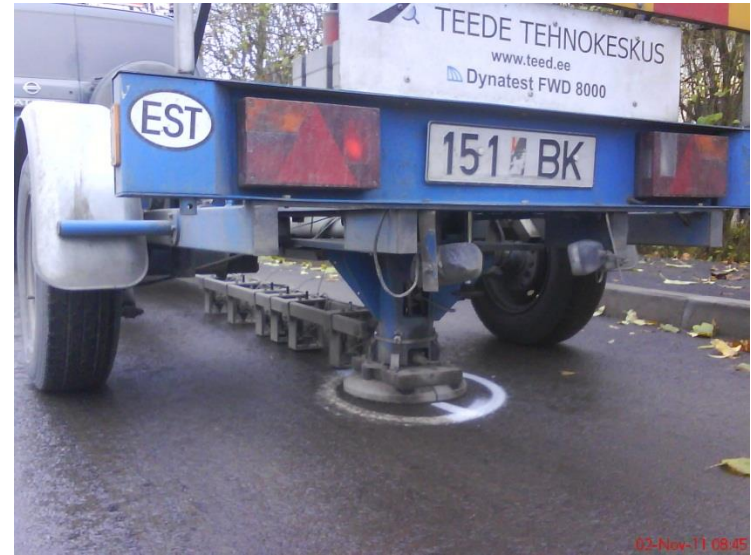
## FWD on the asphalt pavement

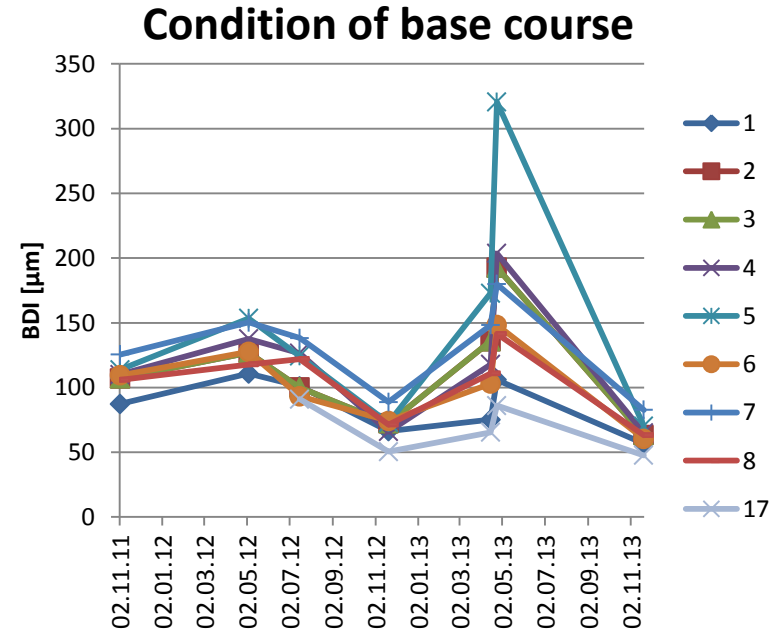
# Variation of FWD deflection basin parameters

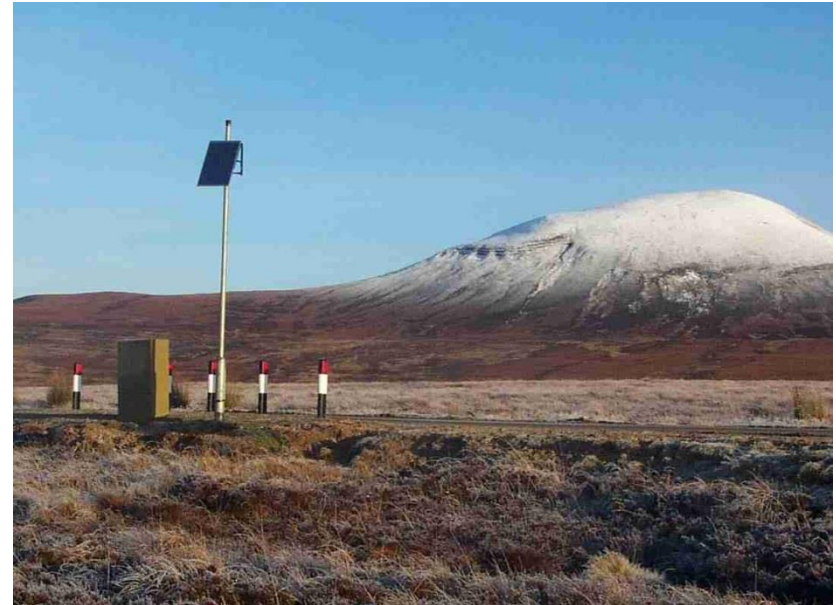
# Percostation – what is this?

- Percostation is a system for continuous monitoring of dielectric constant, electrical conductivity and temperature of materials.
- It was developed by Estonian company Adek OÜ in cooperation with the Finnish company Roadscanners OY for monitoring the critical bearing capacity of roads.

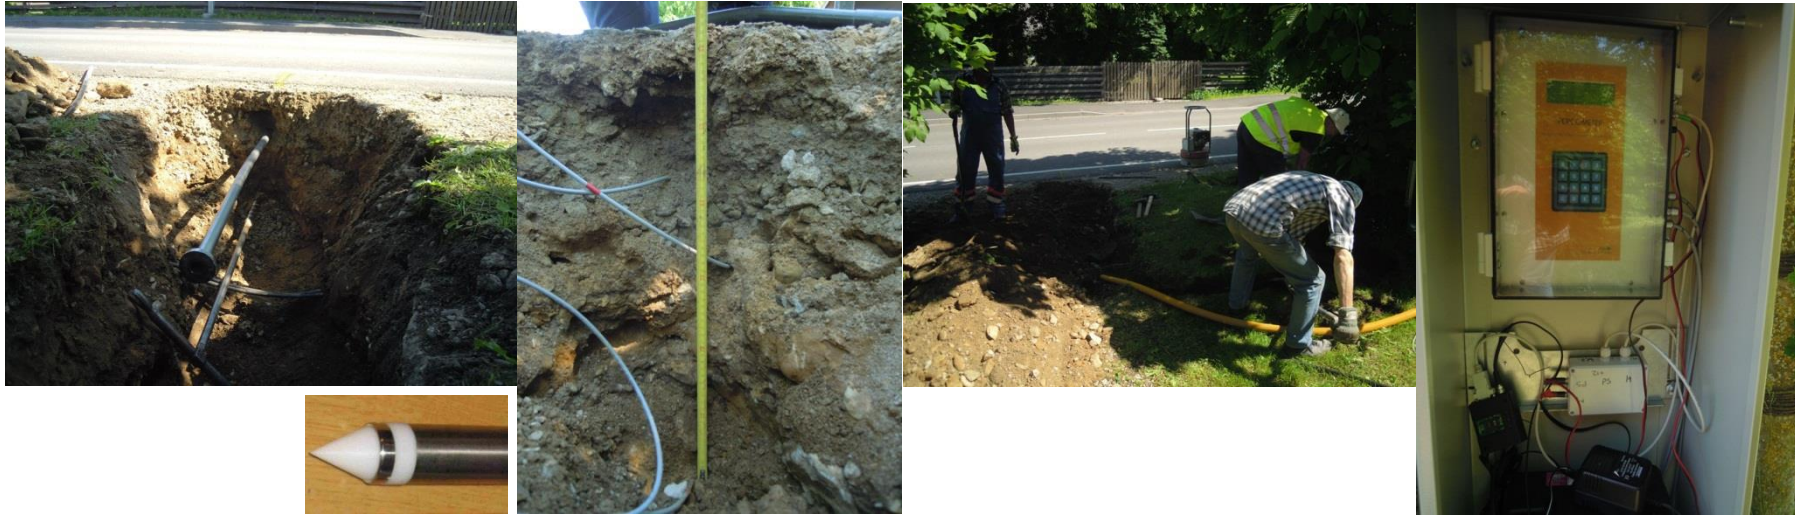
# Monitoring of water content in base course layers by dielectric conductivity measuring station

Percystation sensors are installed into the road structure on depths from top of the asphalt pavement: 24, 33, 63 cm.

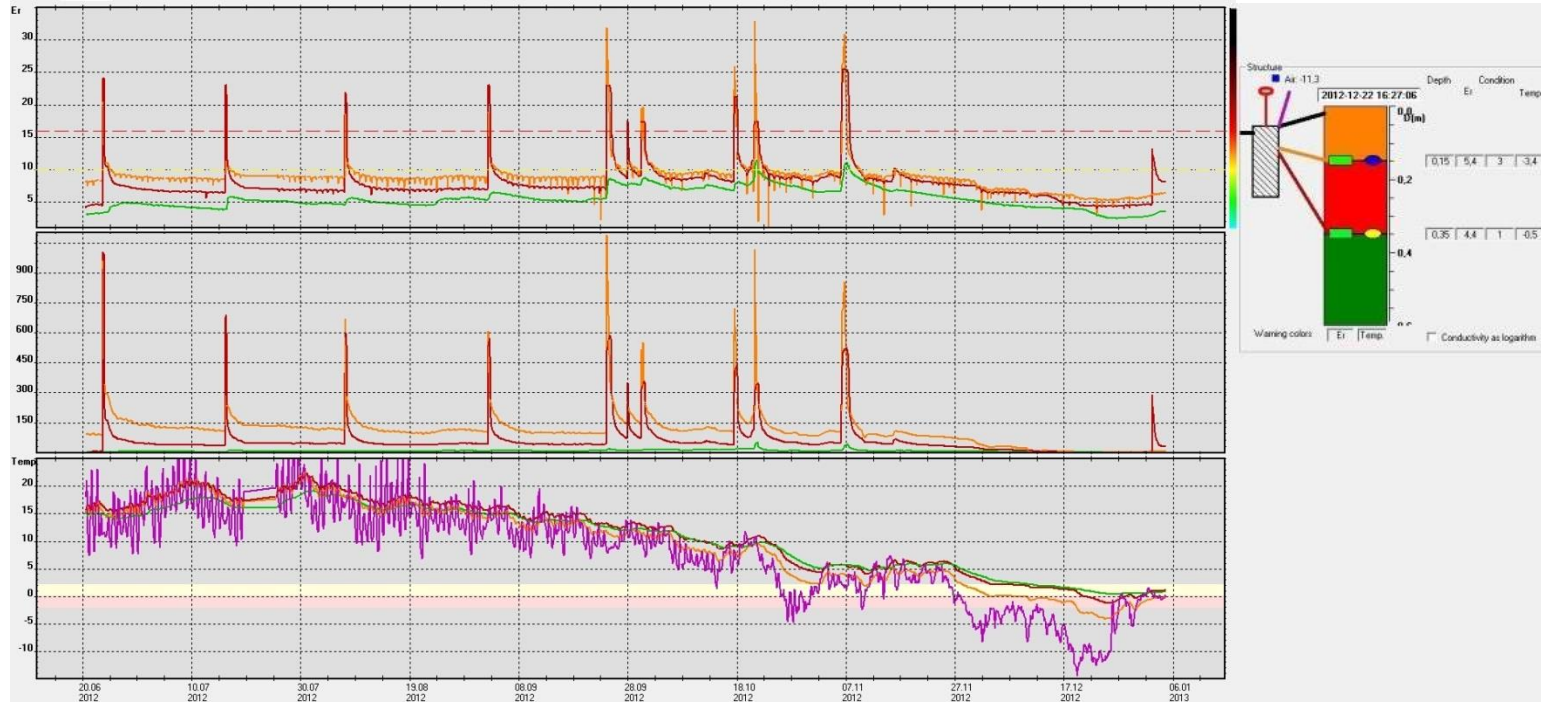
# period from installation until the end of year 2012

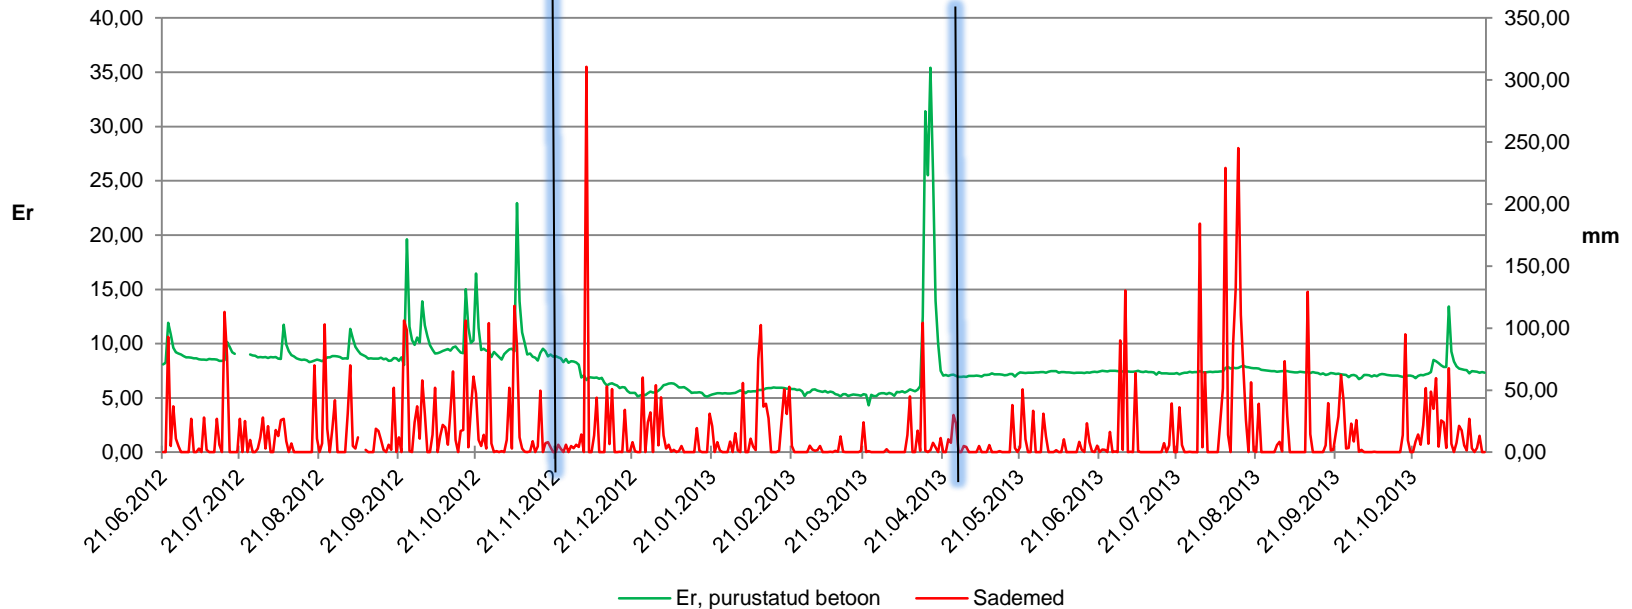
# Dielectrical permittivity in 24 cm depth compared to precipitation near (Jägala) weatherstation

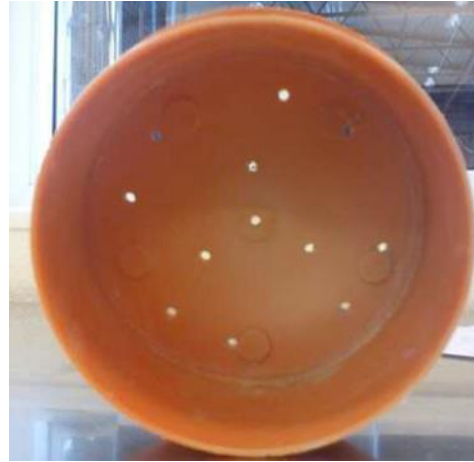
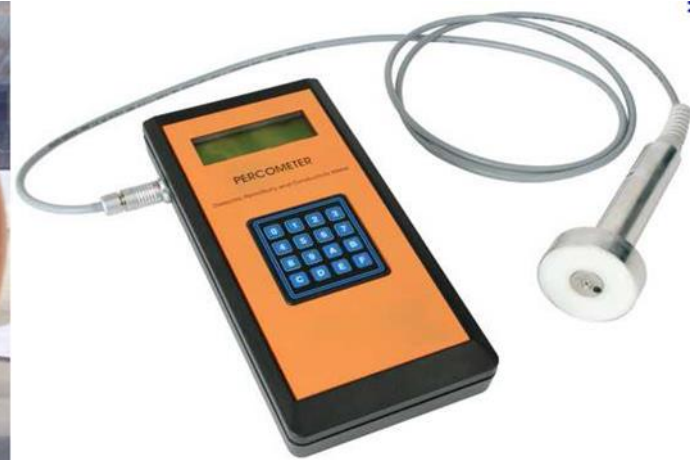
# Laboratory Measurements with Percometer – Tube Suction Test (TST)

The Tube Suction Test was developed by Saarenketo and Scullion at the Texas Transportation Institute (TTI) for investigating the suction properties of various base course aggregates, and has been further tested and developed during 1996-2000 at TTI, the Tampere University of Technology, in the laboratory of the Lappi Region of Finnra, and at the University of Saskatchewan.

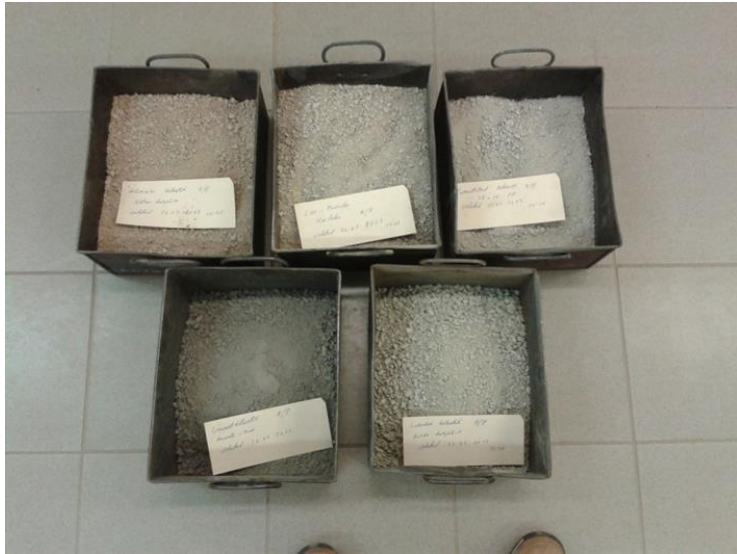
Test materials – fractions 0/8 mm

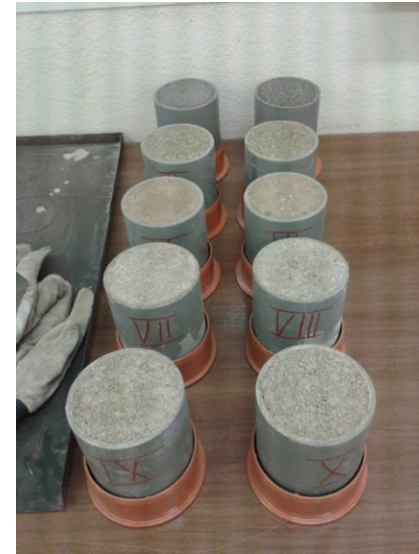
Probes in tubes

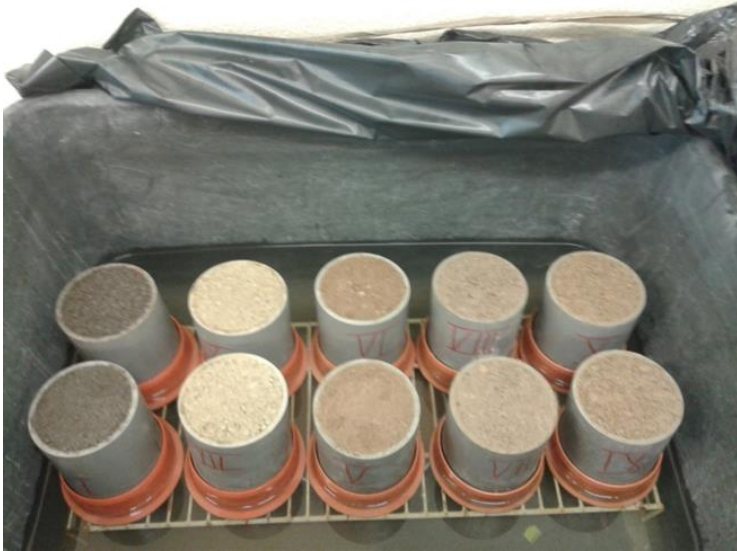
## Conditioning of test probes

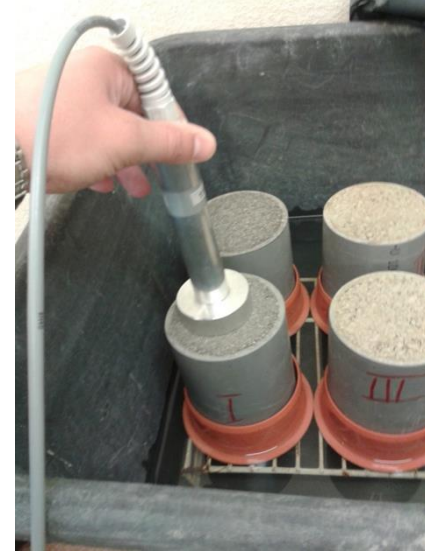
## Testing with Percometer

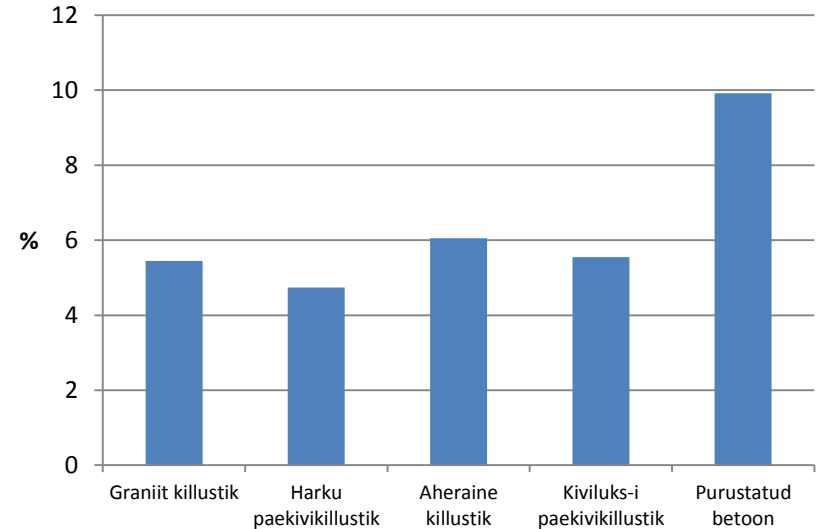
## Optimal water content
